Ministerio de Fomento
AGENCIA ESTATAL DE SEGURIDAD AÉREA

**AIRWORTHINESS
DIRECTIVE**

NUMBER:
01/13

AFFECTED PRODUCTS: Gyroplanes Ultralight (ULM) ELA, models ELA-07 R-115 and ELA-07 R-100 (Type Certificate DGAC No. 284) and homebuilt aircraft aircrafts (Orden de 31 de mayo de 1982, BOE de 5 de junio) built from a "kit" ELA-07.

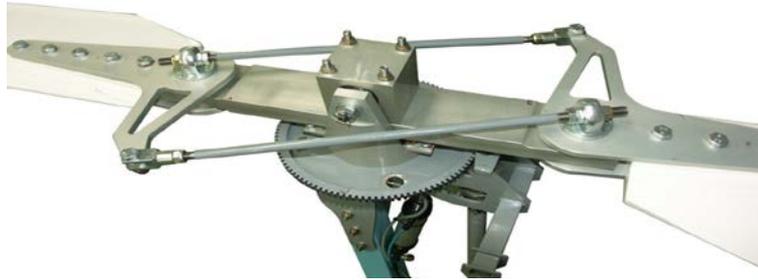
Figure 1. Hub bar (without conicity) P/N: 14-145

3^o If the accommodations of screw heads on the underface of the rotor are mechanized, [hub bar P/N. 14-145 (figure 1) and P/N 14-145B (figures 2 and 3)], the inspection must continue as follow:

3.1 Inspect the possible existence of cracks in the edge of the underface of the rotor hub bar. For this, lower the rotor, and remove screws from the screws housing following the instructions given by the service bulletins of the reference, depending on the hub bar: P/N 14-145 (SB No. 15) or hub bar P/N 14-145B (SB No. 16)

3.1.1 If cracks are found, then the gyroplane must not fly and the hub bar must be replaced by the hub bar P/N 14-145C (fig. 4) following the instructions for replacement given by the Service Bulletin No. 15, for hub bars P/N14-145, and by Service Bulletin No. 16 for hub bars P/N 14-145B.

3.1.2 If no cracks are found, then the gyroplane may be returned to service. Once inspected, the inspection must be repeated each 10 hours of flight, and then must be inspected again by following the guidelines given in 3.1.1.

Finally, before the 150 hours of flight from the first inspection, the hub bar, always, must be replaced by the hub bar P/N 14-145C (fig. 4).

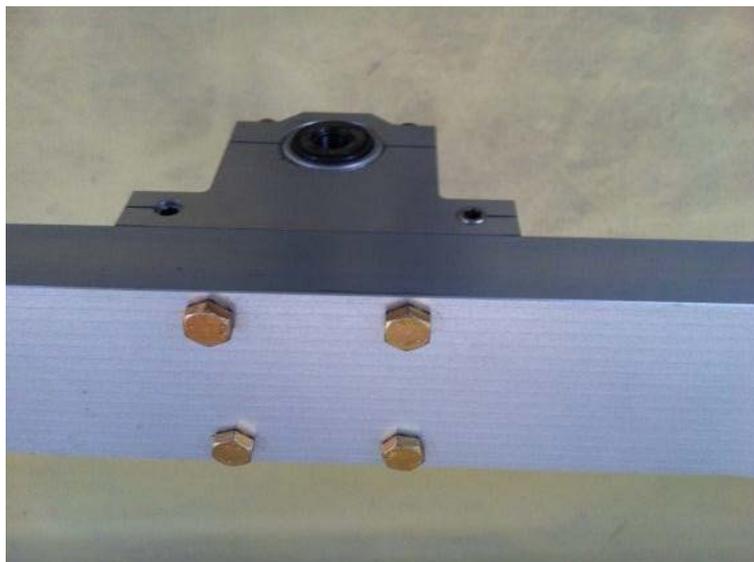
Figure 4. Detail of the Hub bar P/N: 14-145C

2^o If the accommodations of screw heads on the underface of the rotor are not mechanized, there is not necessary any action [hub bar P/N 14-145C (fig. 4)]
