**AFFECTED PRODUCTS:** Amateur built aircraft (Order of May 31, 1982, BOE of June 5) built from the "kit" ZENAIR Zodiac CH 601 XL and equipped with an emergency ballistic recovery parachute system (BRS Aerospace or other) installed in front of the cockpit.

**REFERENCE:** Technical Safety Note 2020-1 "Wrong installation of emergency parachute on Zenair Zodiac CH-601", issued by Air Accident Investigation Unit (Belgium) on date February 28, 2020.

**AIRWORTHINESS  
DIRECTIVE**

NUMBER:  
01/21

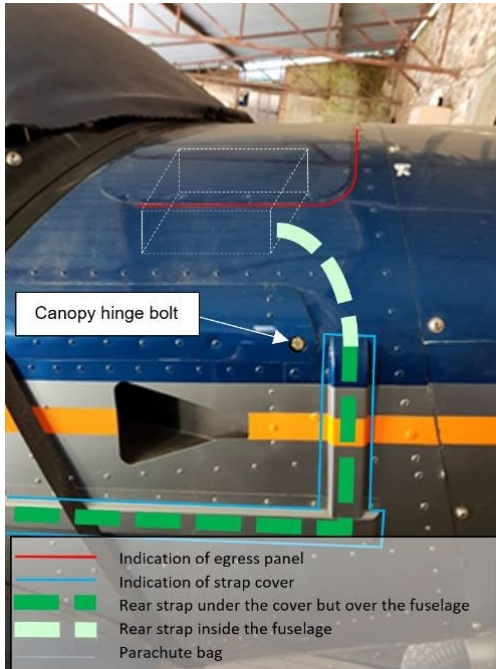
Fig. 1: Incorrect installation

Fig. 1 shows the abnormal rear harness routing inside the front parachute compartment. The rear harness comes into the parachute compartment through a hole cut in the riveted fuselage skin at the level of the canopy hinge bolt (an access hole at that location should only be made and used in the case that the parachute assembly is installed at the back and the strap is anchored at the front structure via that access hole). This installation holds the rear strap under the fuselage skin of the parachute compartment, leading to a strap partially captured in the front fuselage structure and thus not able to extend above the cockpit when the system is activated. This incorrect installation can easily be identified on a Zenair Zodiac ultralight airplane when the fuselage shows a strap cover that ends its installation at the level of the canopy hinge bolt without reaching the lower corner of the egress panel.

2.- If not (like observed in Figure 1) or if any doubt, contact either the airplane manufacturer\*, or the parachute system manufacturer or any specialist in emergency parachute system installation for a safe re-installation of the rear harness;

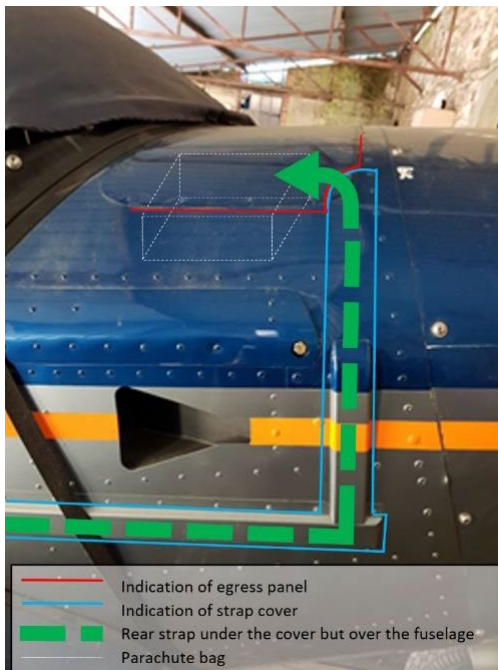
Fig. 2: showing how the correct installation should be like

Fig. 2 illustrates what should be the travel, on the external fuselage skin, of the rear strap into the parachute compartment. It should come inside the compartment through the cut of the blow out panel corner (indicated red on Figure 2, encircled yellow on Figure 3), the panel corner hole being covered and sealed by the end of the harness strap cover that must reach the edge of the blow out panel (indicated blue). This routing allows the rear harness to extend full and freely above the cockpit and, concurrently with the 2 front harnesses, to anchor the parachute around the center of gravity of the airplane, completely under tension.

1.- Before the next flight, check the routing of the rear harness into the front parachute compartment, and verify if the rear harness strap cover reaches the front corner of the parachute compartment blow out (egress) panel as shown in Figure 2 and Figure 3 (correct installation);

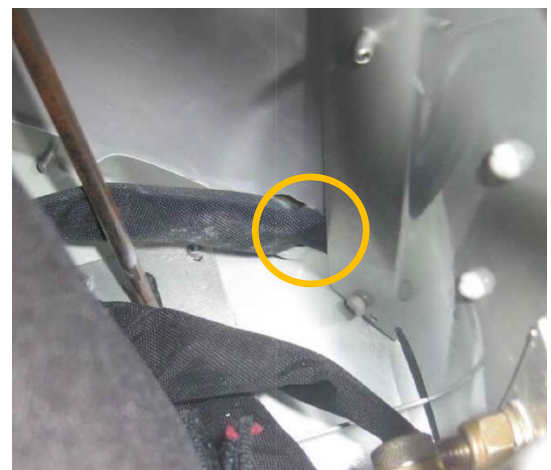
Fig. 3: picture taken from an installation Inside showing the hole in the egress panel
