**AIRWORTHINESS
DIRECTIVE**

NUMBER:
02 / 09

AFFECTED PRODUCTS: Amateur built aircraft (Order 31 May 1982, BOE 5 June) constructed from kits PEGASUS QUIK all versions, and any other aeroplane (home built or Type Certificate) fitted with CKT stainless steel twin exhausts, which have serial numbers 8230 to 8430.

SERVICE BULLETIN NUMBER 127
including
MODIFICATION M228

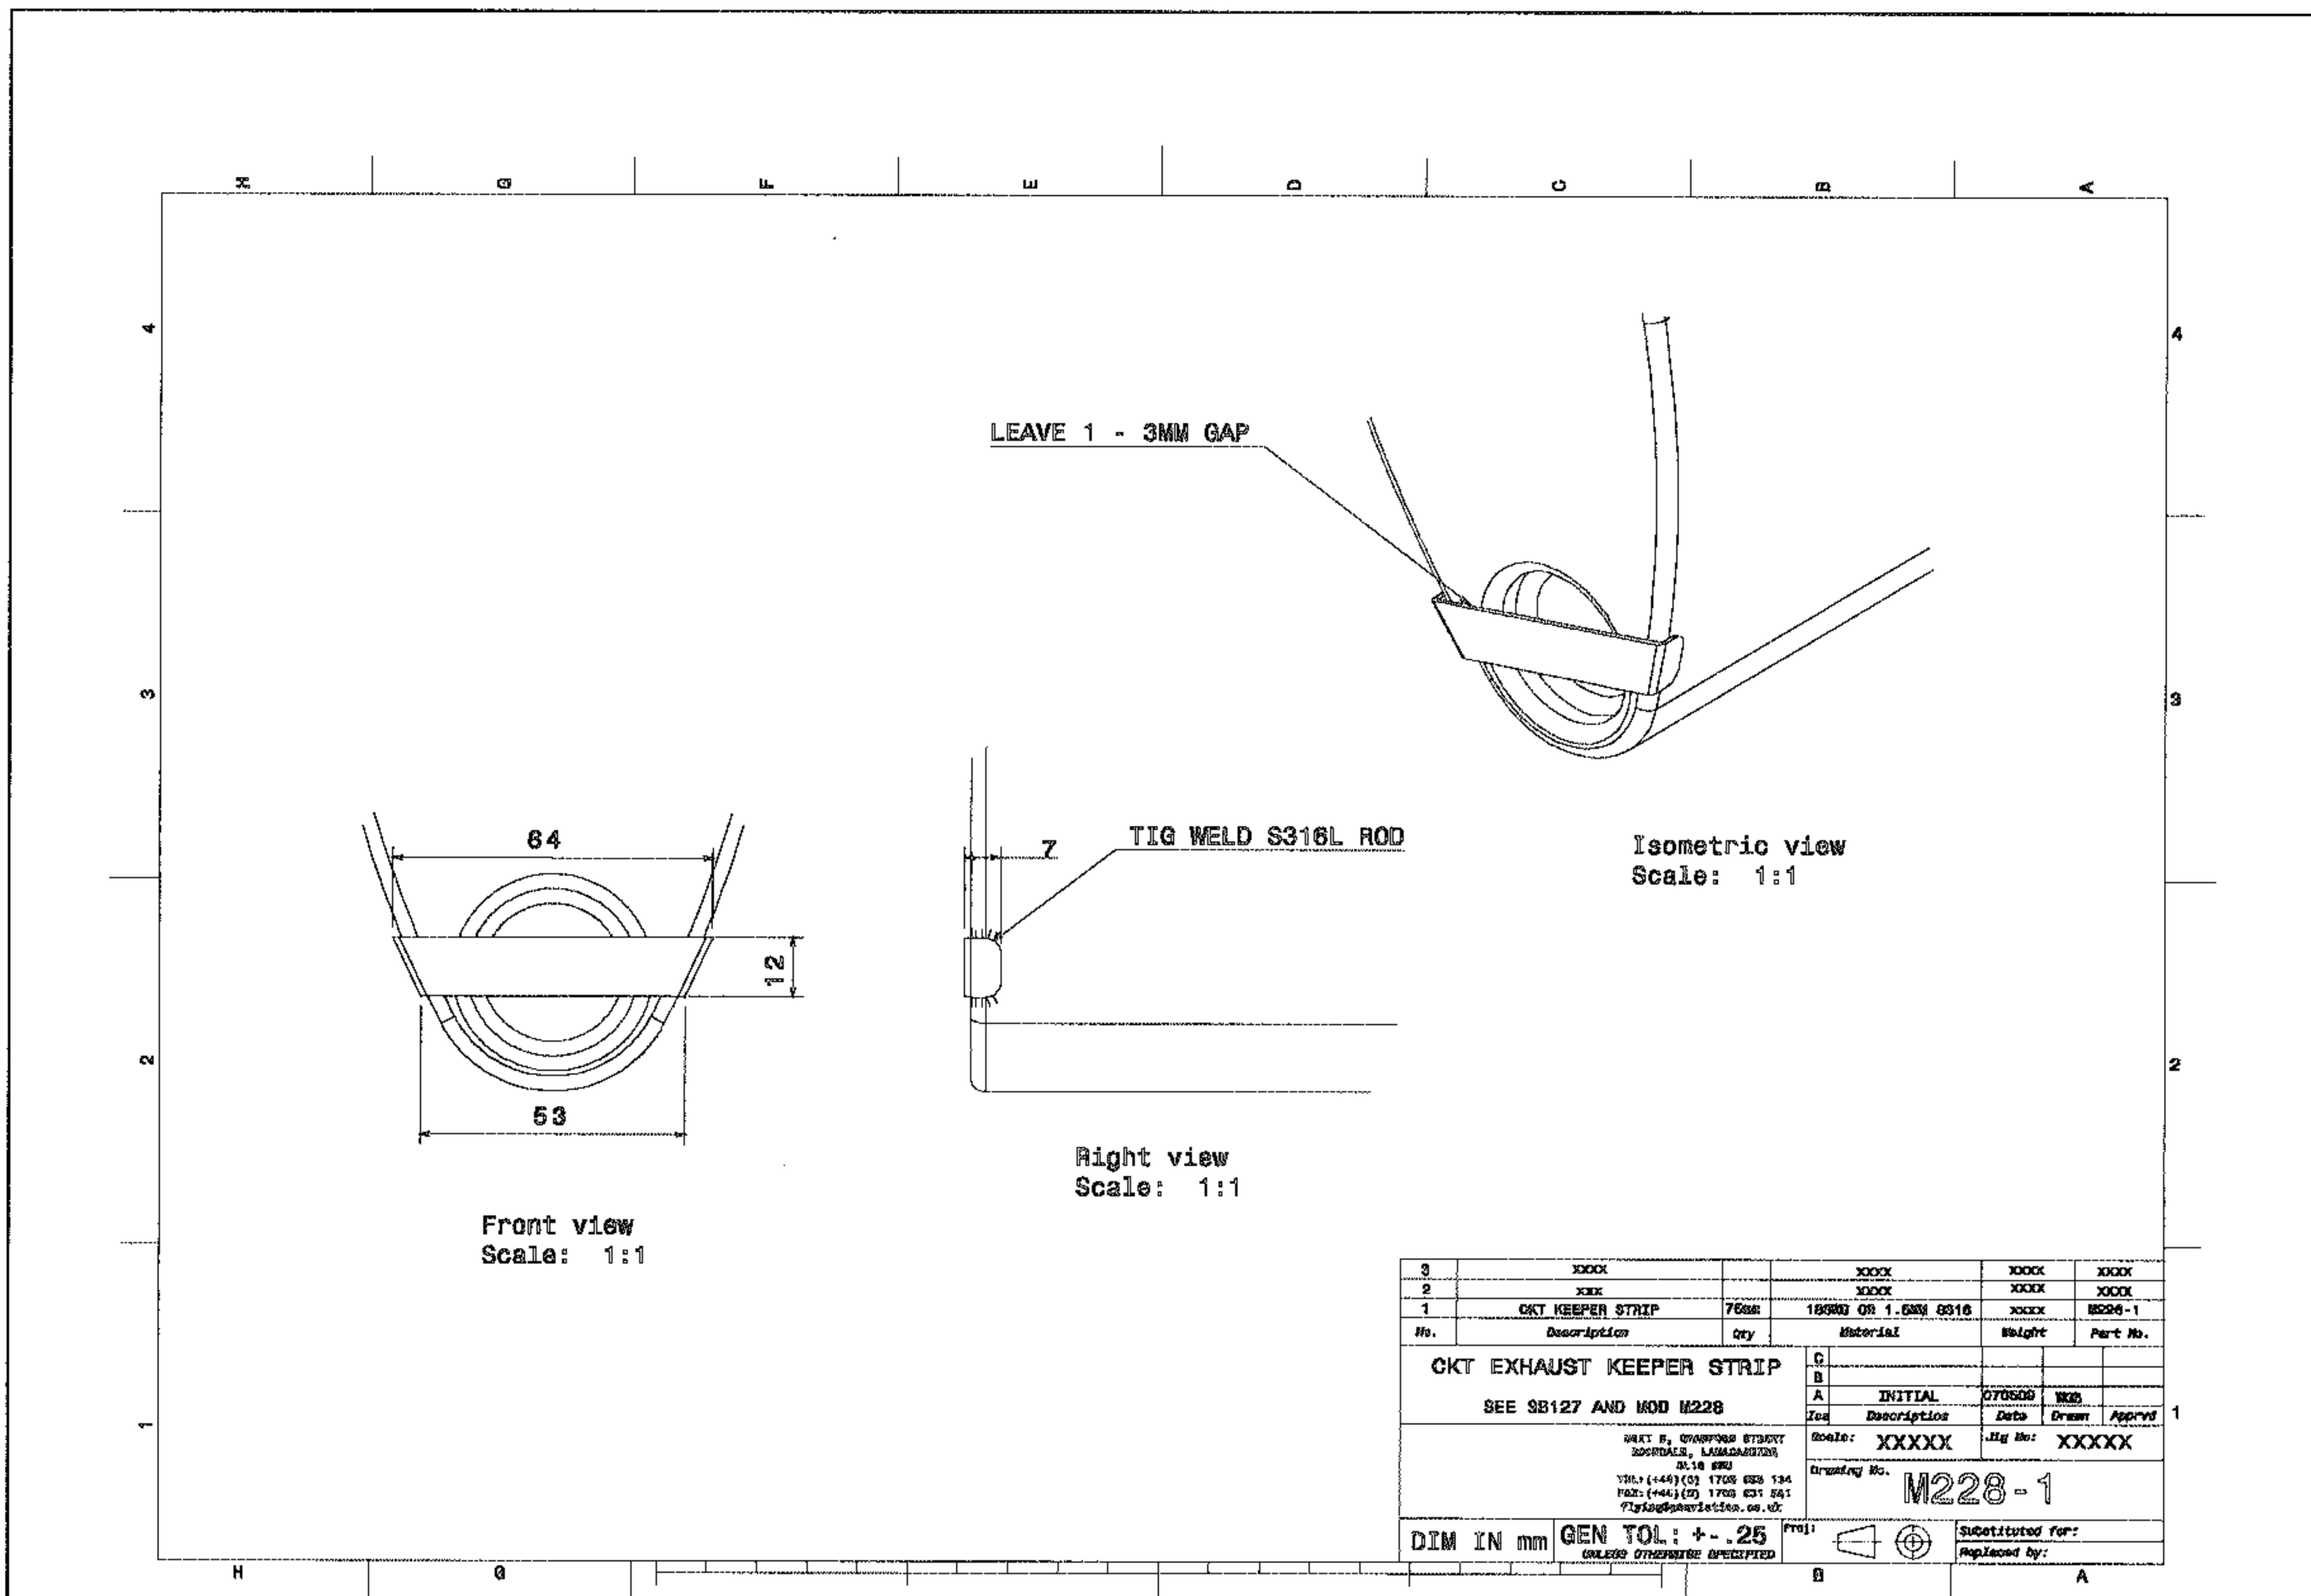
Fig 3 Exhaust Keeper modification M228

If the inner ends of the baffle tubes and internal baffles are secure, modification M228 can be carried out (see fig. 3). It provides a backup retainer if the baffle should become loose. Thoroughly clean the area. Do not use any dissimilar wire brush metals and do not mark with graphite or carbon pencils. Weld repair any cracks found using a stainless steel 316L welding rod and TIG process. Fit a 12mm wide x 18swg (1.22mm) or 1.5mm S316 strip with 7mm bent edges as shown, weld to the silencer ONLY at the corners, over the existing corner weld. The repair/modification must be carried out by an aviation approved welder qualified for thin (0.9mm) stainless steel. FAA publication AC43-13-1B is a useful guide to procedures.
