DIRECTIVA
DE
AERONAVEGABILIDAD

NÚMERO:
02 / 09

SERVICE BULLETIN NUMBER 127
including
MODIFICATION M228

TITLE	CKT exhaust
CLASSIFICATION	The CAA have classified this bulletin as Mandatory.
COMPLIANCE	All aircraft, Inspection before further flight.
APPLICABILITY	All Quik, GT450 & QuikR fitted with CKT stainless steel twin exhausts. The CKT exhaust serial number is stamped on one end cover plate.

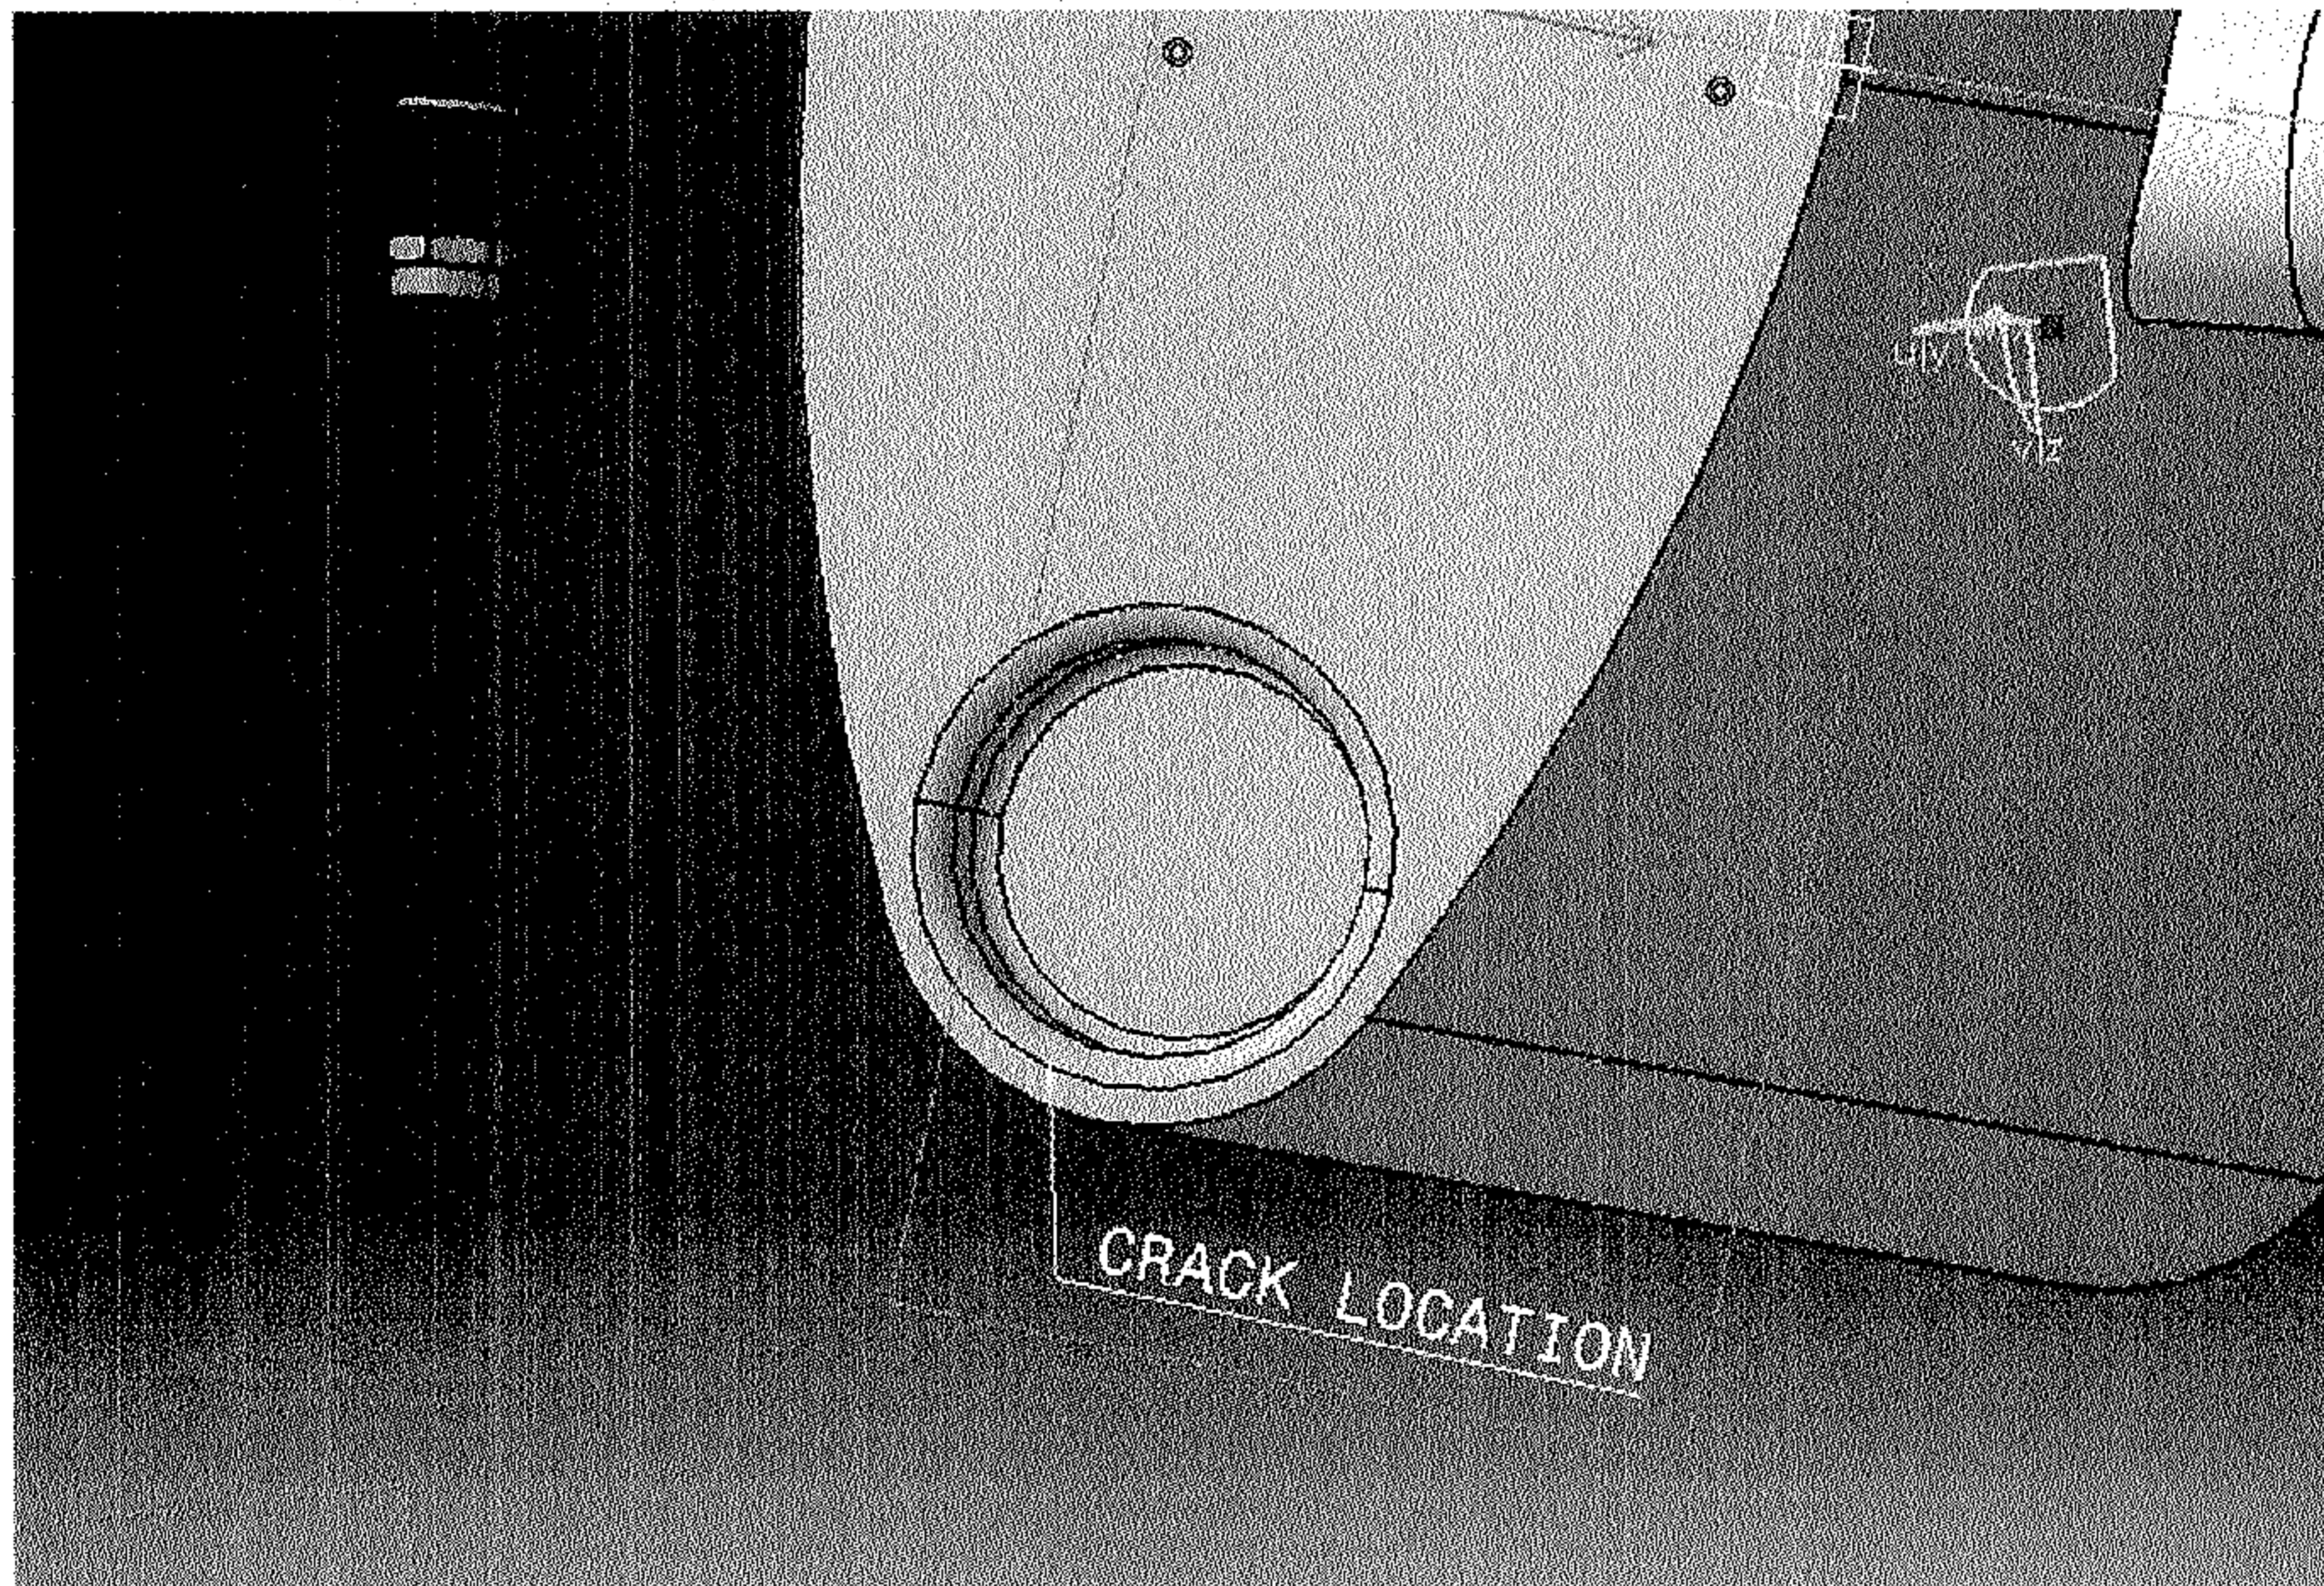
The CKT exhaust silencer has separate front and rear perforated baffle tubes which are welded to the front and rear end cap flanges and plugged with a cap. A fatigue failure of a pair of exhausts serial no. 7811107 has occurred at 125 hours, around the flange edge on the rear end cap, at the weld edge (see fig 1). The baffle tube came free and was ejected from the silencer and hit the propeller. Fortunately this happened at low power on approach, propeller damage was localised and the baffle tube missed the sail; under high power the consequences could be very serious.

The exhausts were fitted to the prototype QuikR (Rotax 912s engine) where failure may be more prevalent due to use of high power settings. Failure has been caused by gas pressure pulses pushing the rear internal baffle plate inwards, causing disengagement of the inner baffle plate from the baffle tube, allowing free vibration of the baffle tube end, leading to failure of the end cap joint.

Fig 1. Crack location all round weld outer edge

Before further flight, using good light and a magnifying glass, closely inspect the area around all 4 silencer end caps for cracks, particularly on the weld edges (see fig 1). If cracks are noted, contact P&M Aviation, if possible by email attaching pictures of the damage, hours run, aircraft and exhaust serial numbers. The aircraft must not be flown with cracks in this area.

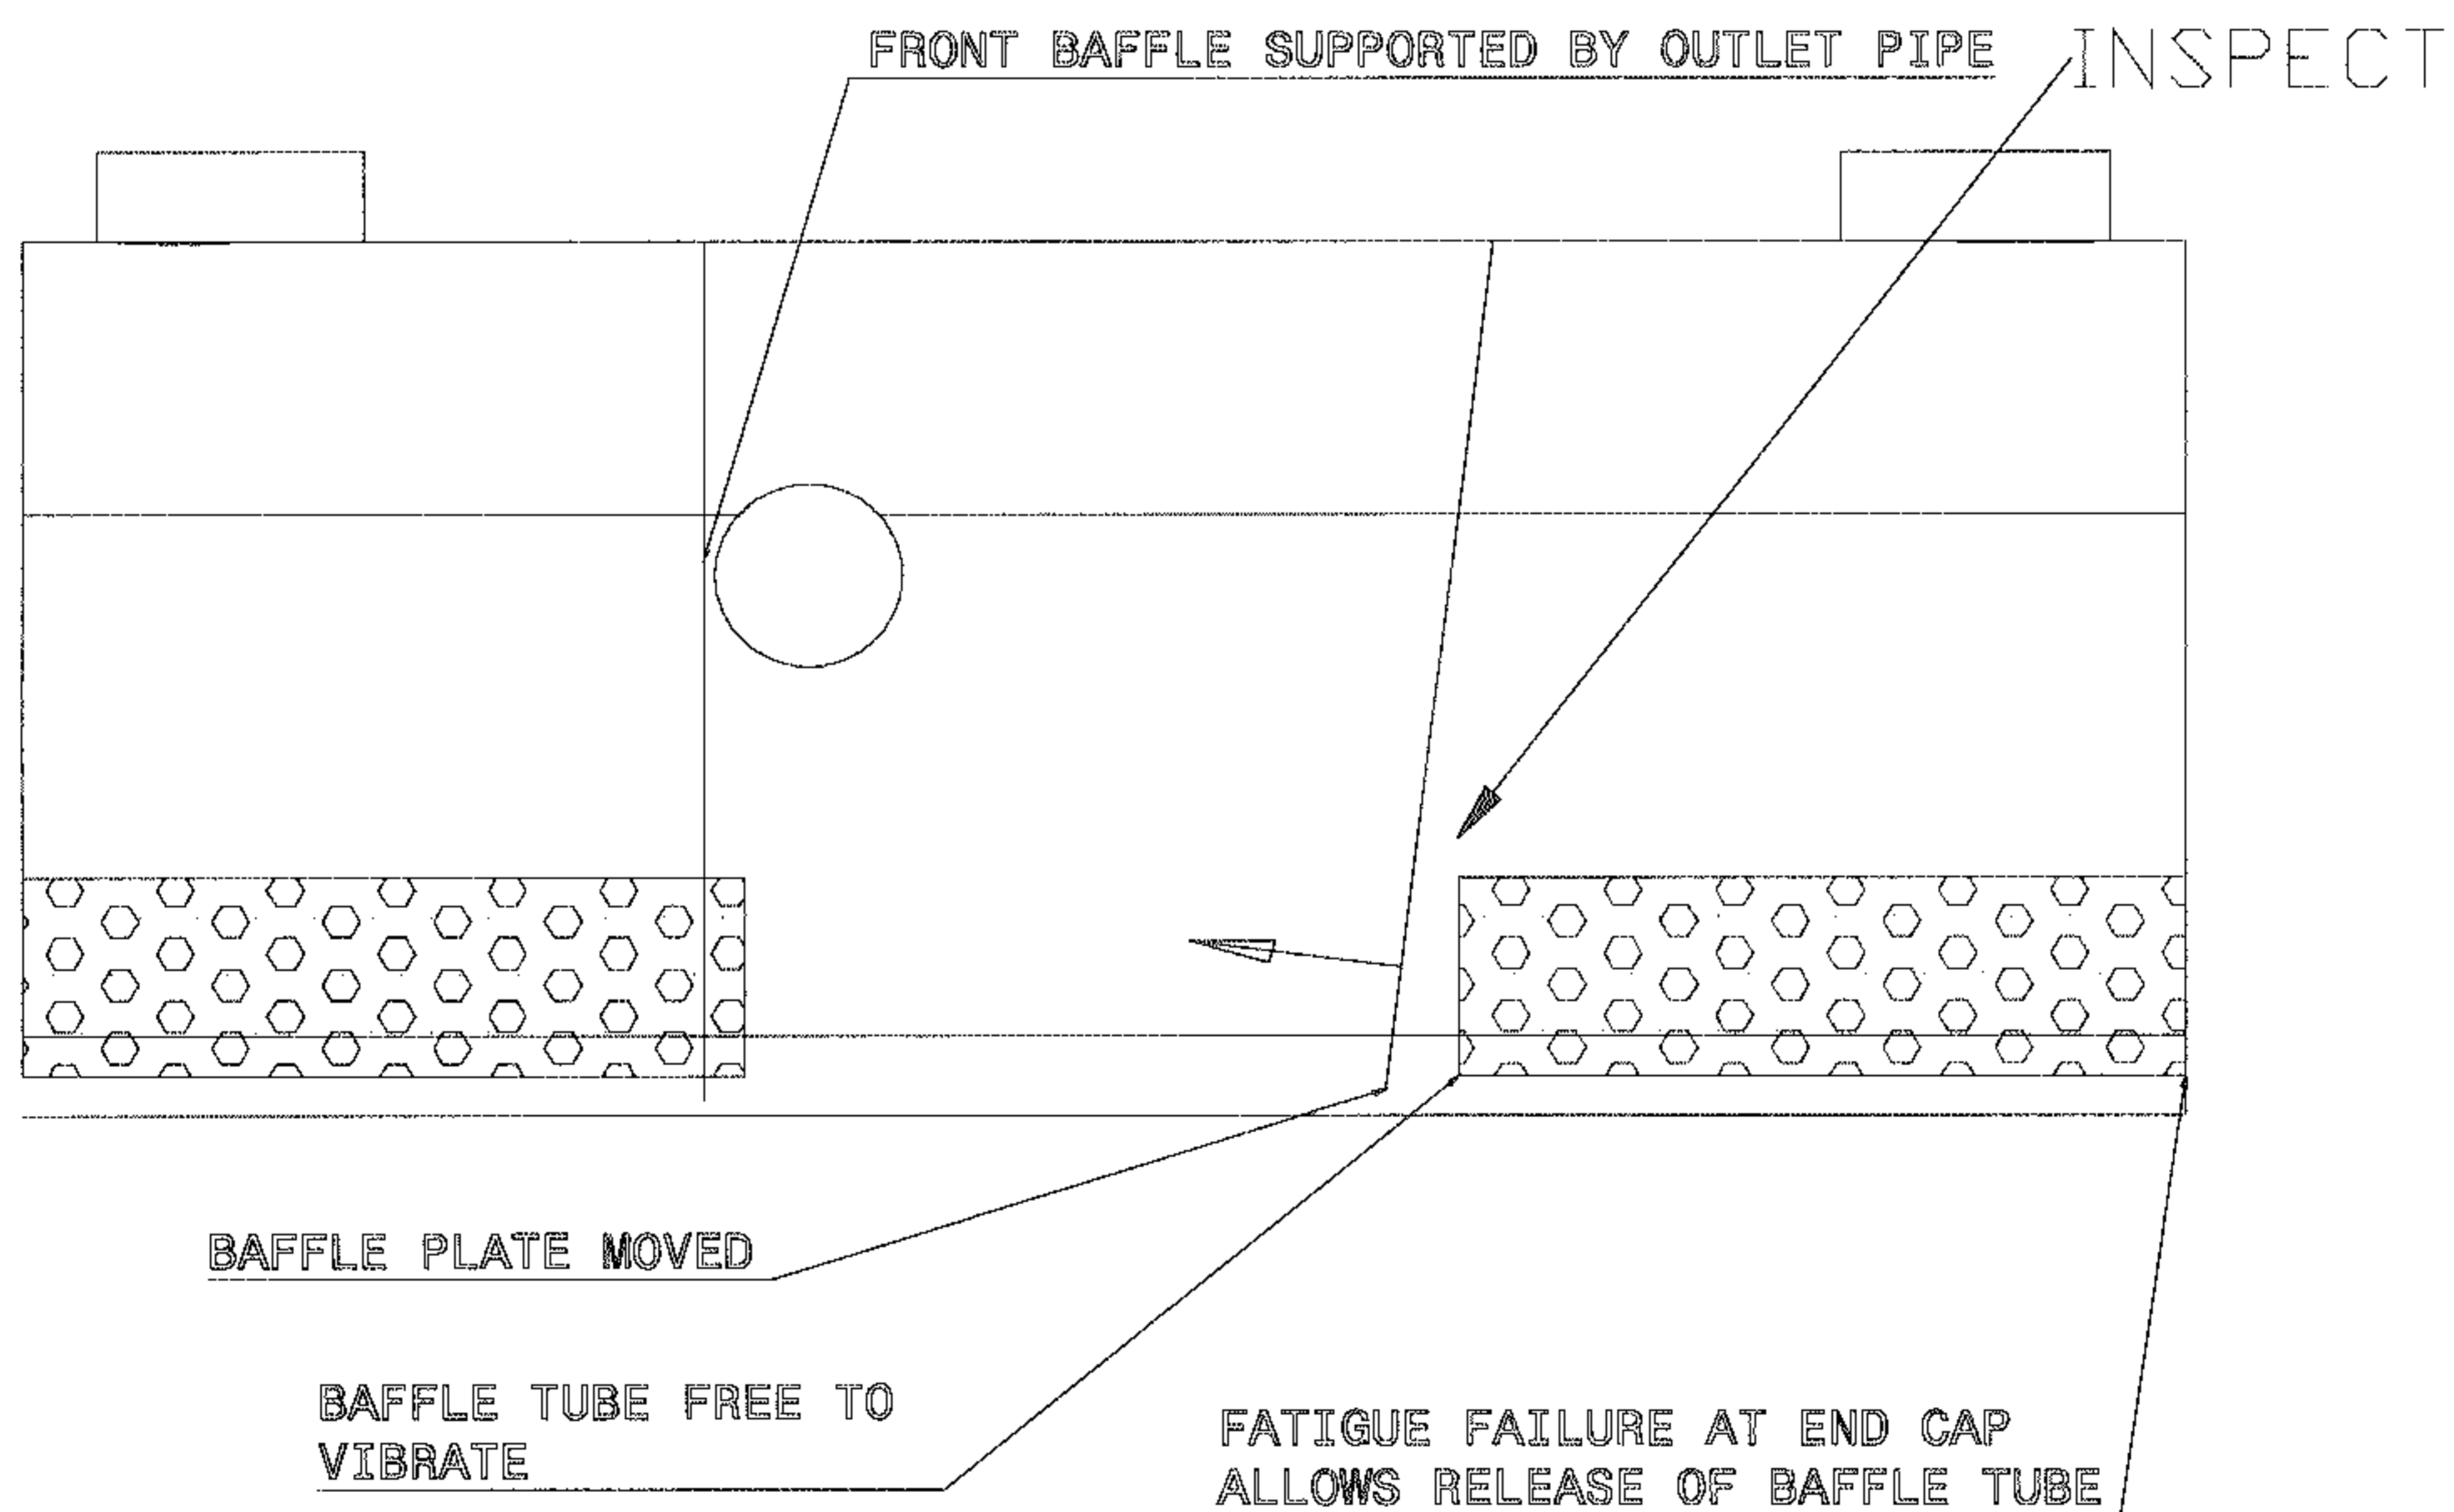
See fig. 2. Through the exhaust header pipe holes, using a torch and mirror, inspect the welded connection between the internal baffle plate and the end of the perforated baffle tube. Try pushing the bottom of the internal baffle plate inwards. If the baffle plate has moved inwards towards the centre of the exhaust and the baffle tube

has disengaged from the baffle plate, *the exhaust must be replaced*. Disengagement is more likely on the rear internal baffle, as the front internal baffle is supported by the outlet pipe.

Fig 2. Movement of inner baffle plate.

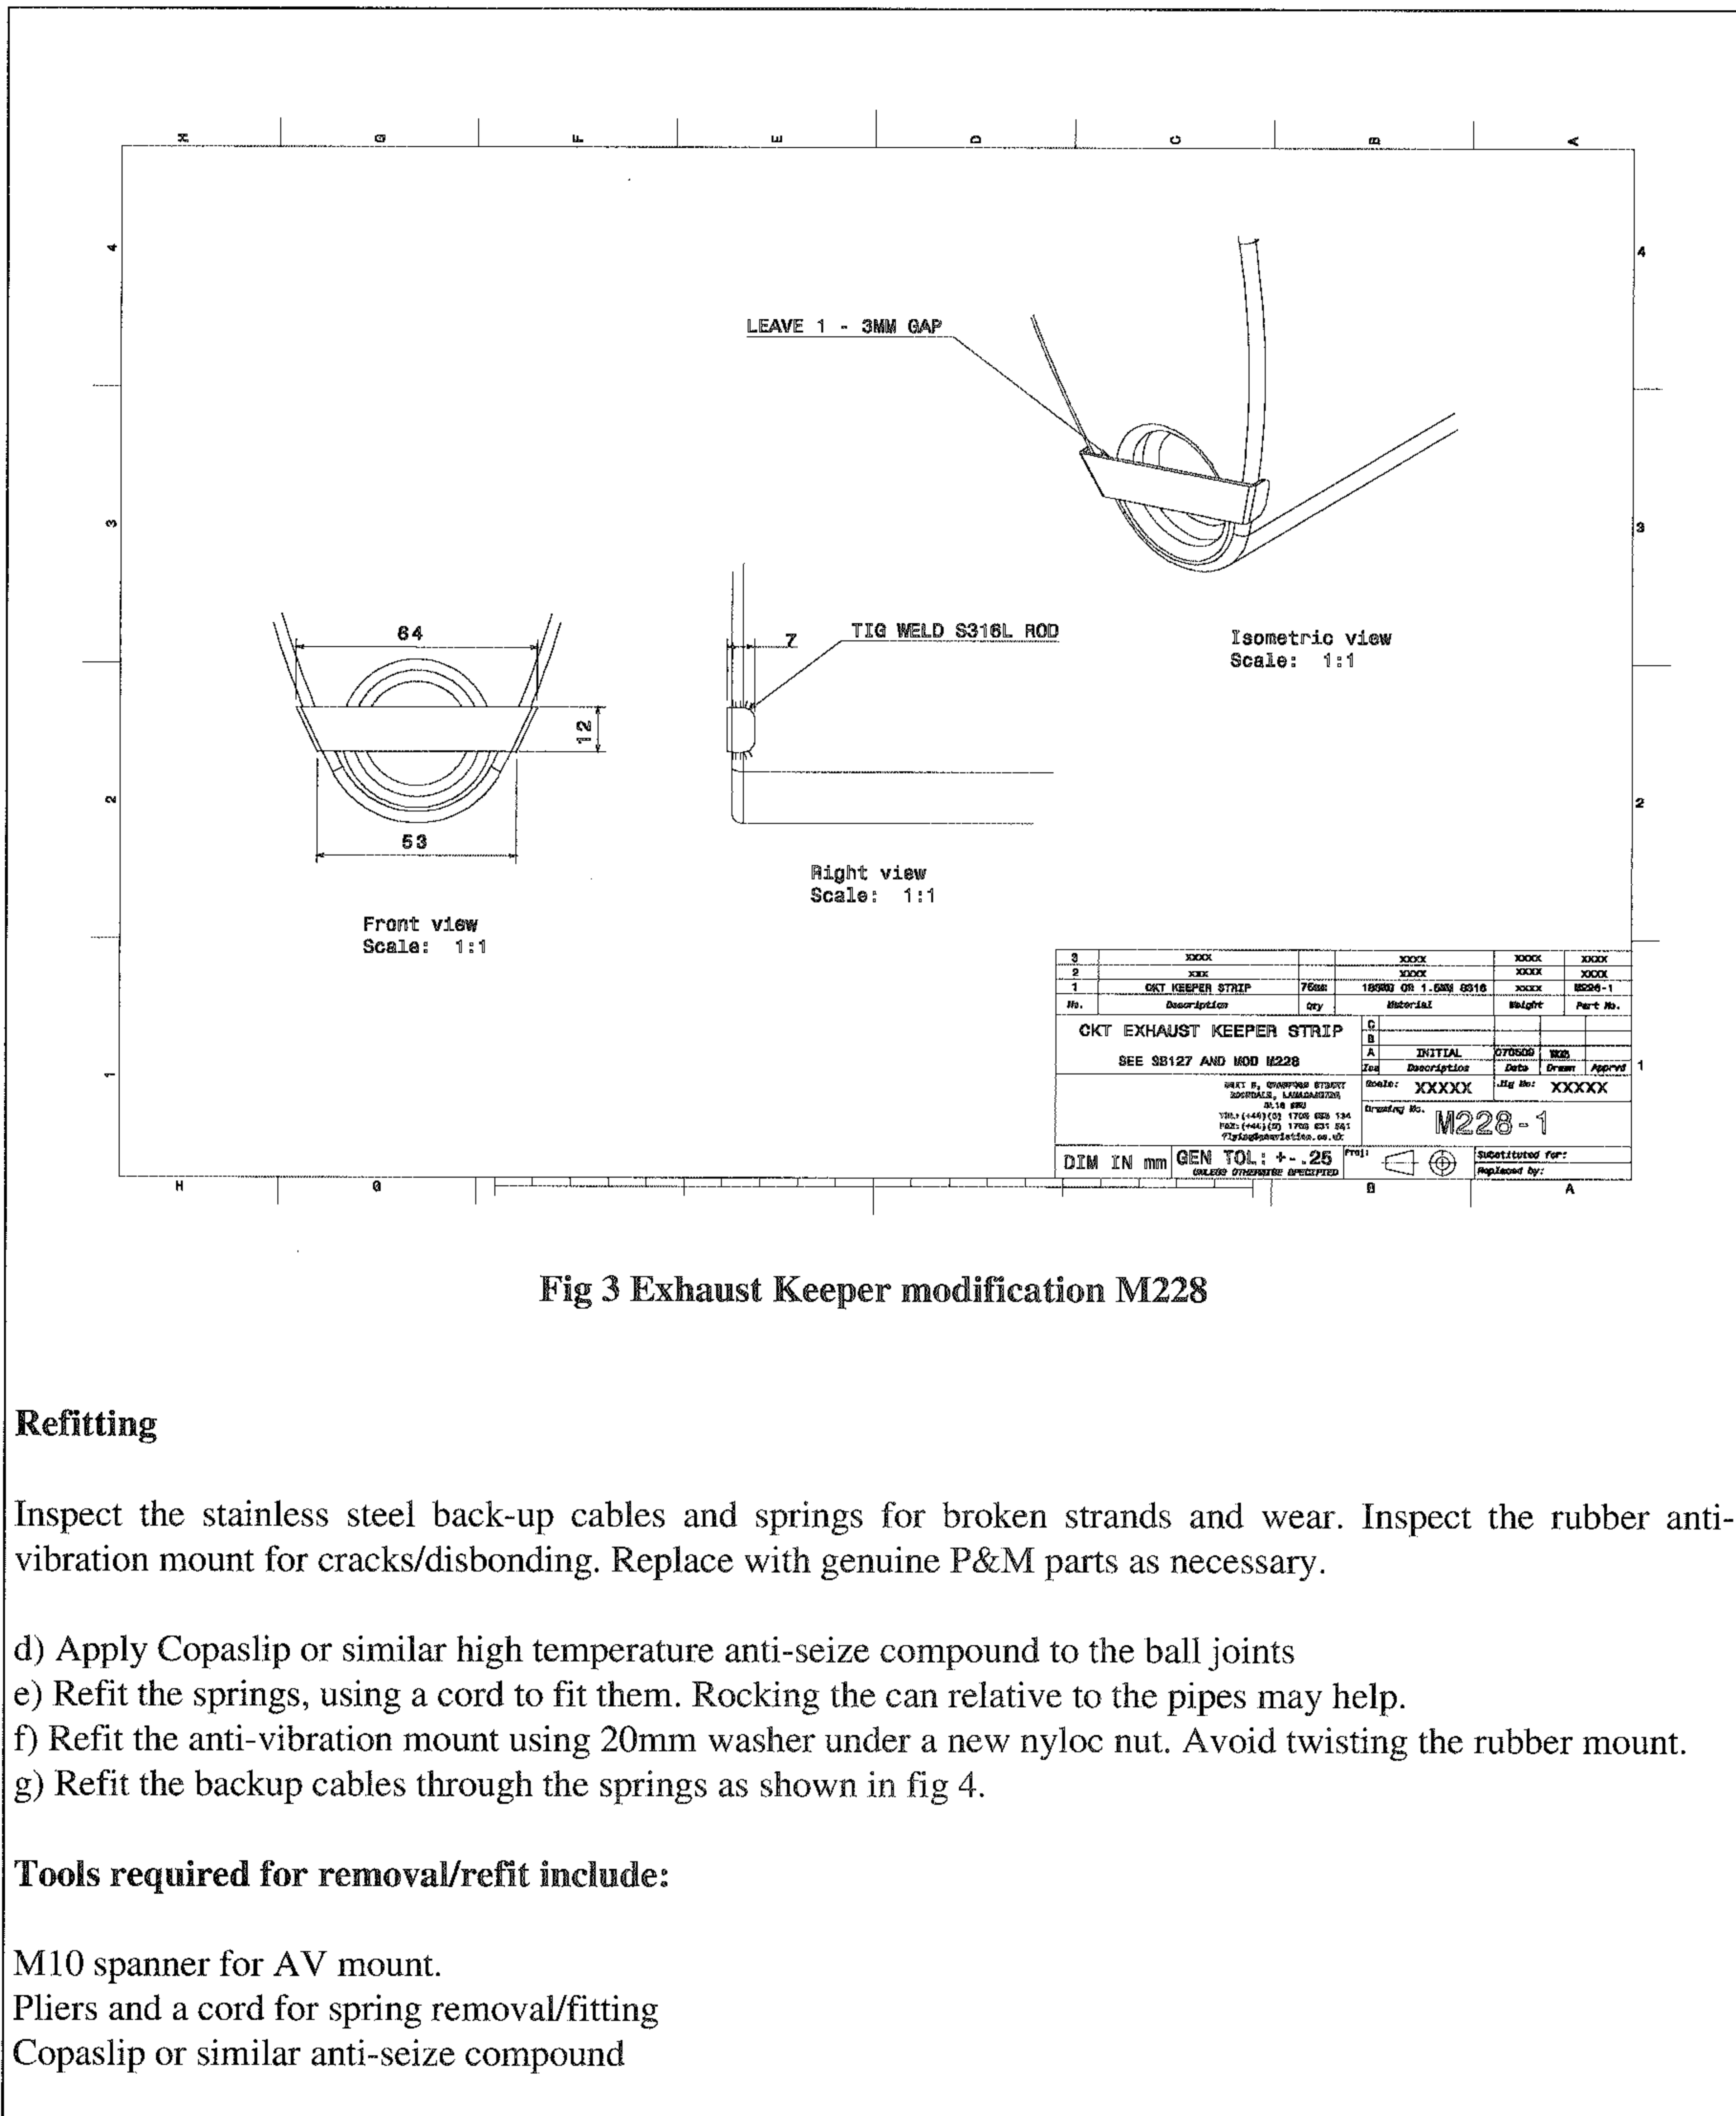
Fig 3 Exhaust Keeper modification M228

If the inner ends of the baffle tubes and internal baffles are secure, modification M228 can be carried out (see fig. 3). It provides a backup retainer if the baffle should become loose. Thoroughly clean the area. Do not use any dissimilar wire brush metals and do not mark with graphite or carbon pencils. Weld repair any cracks found using a stainless steel 316L welding rod and TIG process. Fit a 12mm wide x 18swg (1.22mm) or 1.5mm S316 strip with 7mm bent edges as shown, weld to the silencer ONLY at the corners, over the existing corner weld. The repair/modification must be carried out by an aviation approved welder qualified for thin (0.9mm) stainless steel. FAA publication AC43-13-1B is a useful guide to procedures.

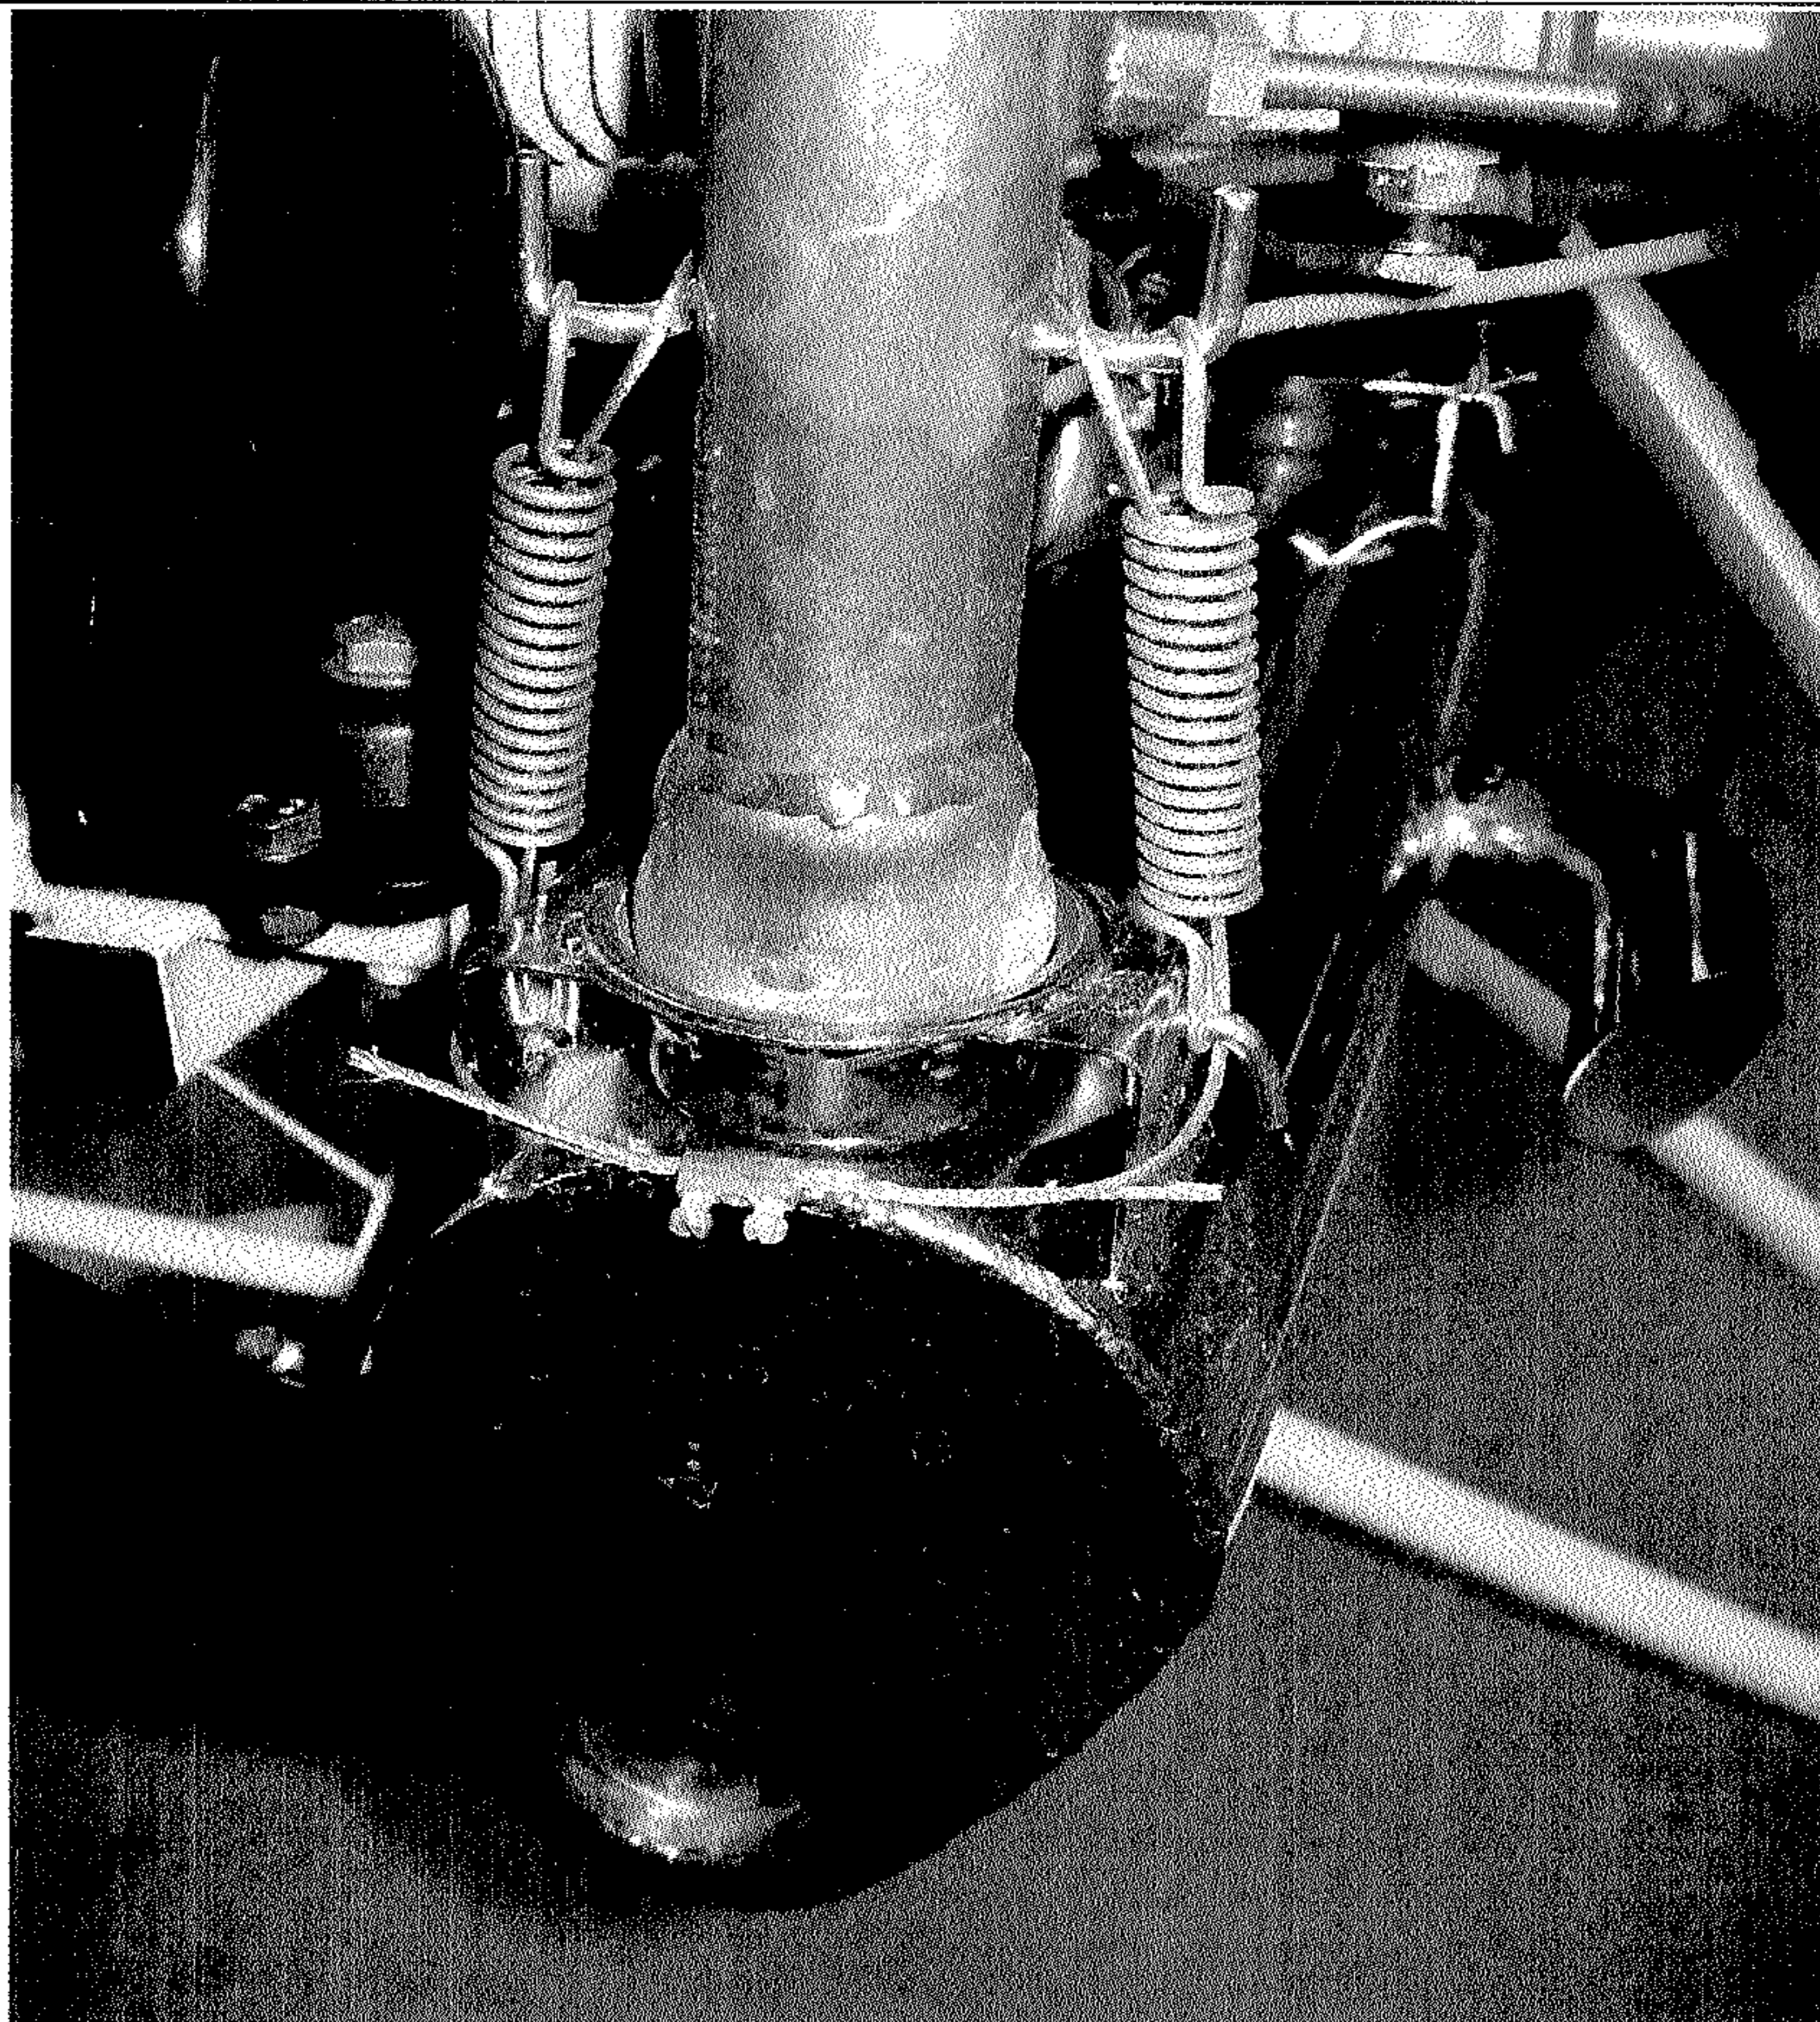
Fig 4 Exhaust springs and backup cable

- d) Apply Copaslip or similar high temperature anti-seize compound to the ball joints
- e) Refit the springs, using a cord to fit them. Rocking the can relative to the pipes may help.
- f) Refit the anti-vibration mount using 20mm washer under a new nyloc nut. Avoid twisting the rubber mount.
- g) Refit the backup cables through the springs as shown in fig 4.
