## AIRWORTHINESS DIRECTIVE

NUMBER:  
02/17

**AFFECTED PRODUCTS:** Ultralight Gyroplanes (ULM) ELA AVIACION, models ELA-07 (Type Certificate DGAC No. 284/1) and amateur built aircraft (Order 31 May 1982, BOE 5 June) constructed from kits.

**MANUFACTURER:** ELA AVIACION, S.L.

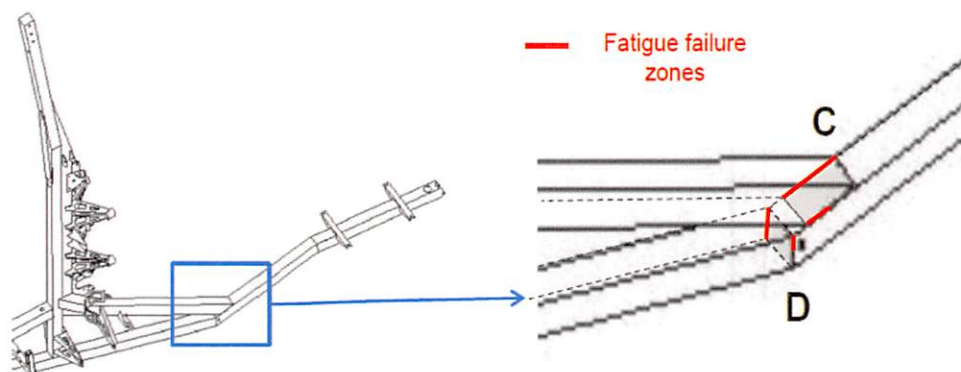
Figura 1

**DESCRIPTION:** The tail boom of an ultralight gyroplane ELA-07 broke in flight. As part of its technical investigations, The Bureau of Enquiry and Analysis for Civil Aviation Safety (BEA) identified fatigue failures in the welded areas C and D of the tail boom (see Figure 1). The repeated loads (without their nature being perfectly identified) and defects found in the welds have contributed to initiate the fatigue cracks, leading to the separation of the tail boom. As a consequence, General Directorate of Civil Aviation of France has issued the Airworthiness Directive CN 2017-ULM-001, dated 07/05/2017.

Note: a paint flaking may be indicative of the presence of a crack.

1.- Before the next flight, after every 4 months or 100 flight hours (first time reached), visually inspect the welded joints C and D (see Figure 1) with a magnifying glass or other magnifying device.

Any suspicion of a crack in the vicinity or in the welds must be lifted, if necessary by means of appropriate detection means. In case of doubt, ask the manufacturer for advice.

2.- In case of crack:

- flights are prohibited until the application of corrective measures defined by the manufacturer.
- inform AESA: [certificacion.aesa@seguridadaerea.es](mailto:certificacion.aesa@seguridadaerea.es)

3.- After the repair / reinforcement measures defined by the manufacturer have been applied, the repetitive inspection defined in § 1 above must be continued every 12 months or 200 flight hours (first of the deadlines reached) unless the manufacturer recommend lower intervals.
